Main Features

High level Integrated HGV Solution

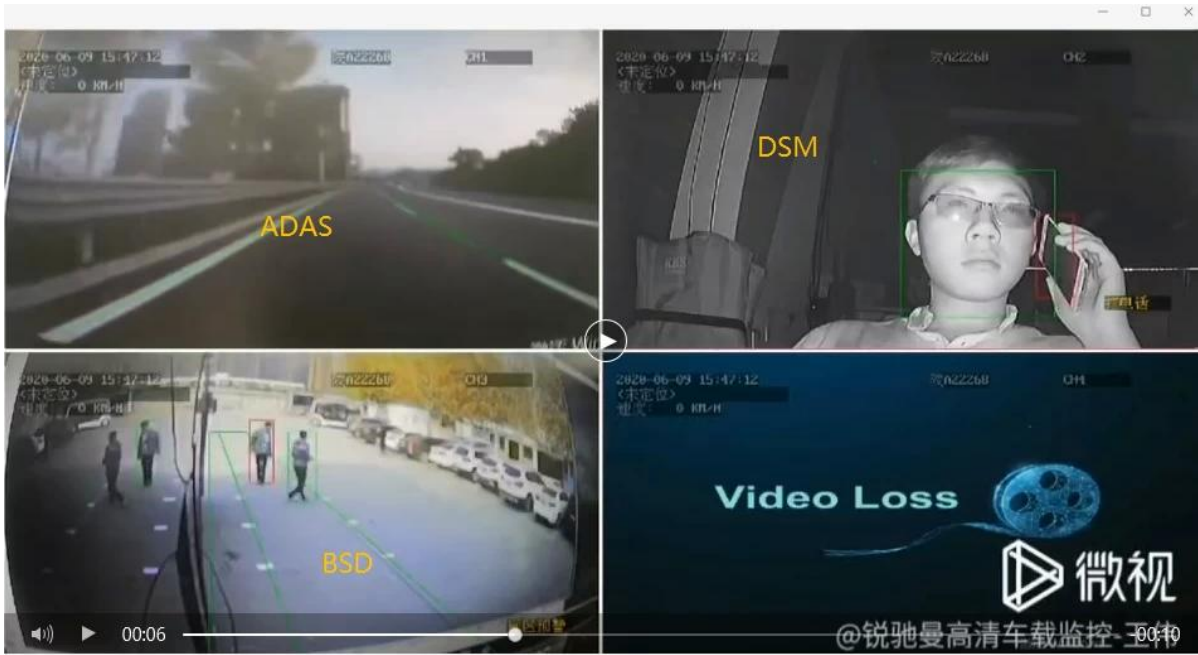
AI Function (ADAS+DSM+BSD)

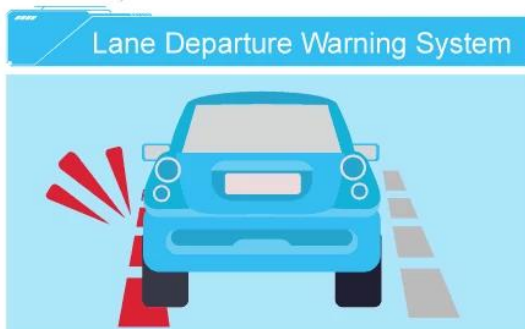
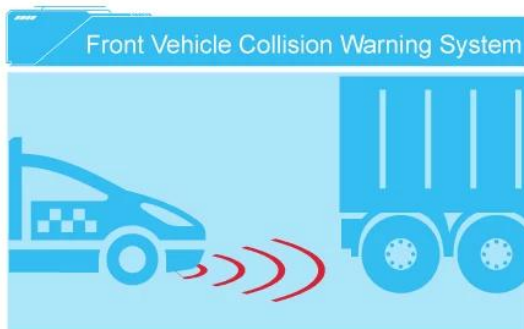
ADAS ADAS Front Active Safety Warning System

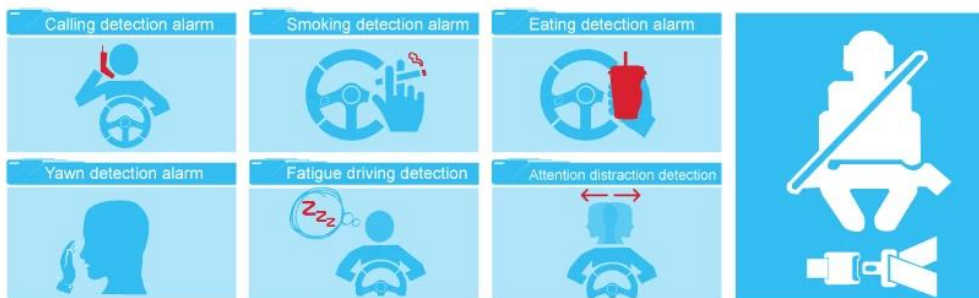
DSM Dangerous Driving Behavior Pre-warning System
